Journal of Constructional Steel Research

Strengthening of corroded steel CHS columns under axial compressive loads using CFRP

Omid Yousefi^a, Kambiz Narmashiri^{b,*}, Amir Ahmad Hedayat^c, Ali Karbakhsh^a

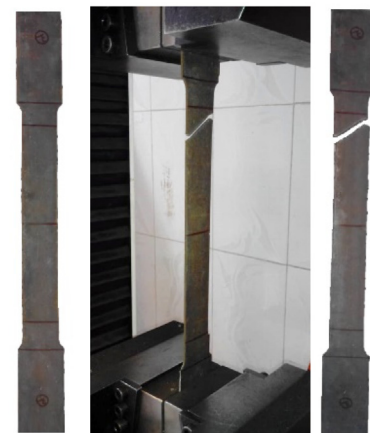
Fig. 2. Tensile test and the failure mechanism.

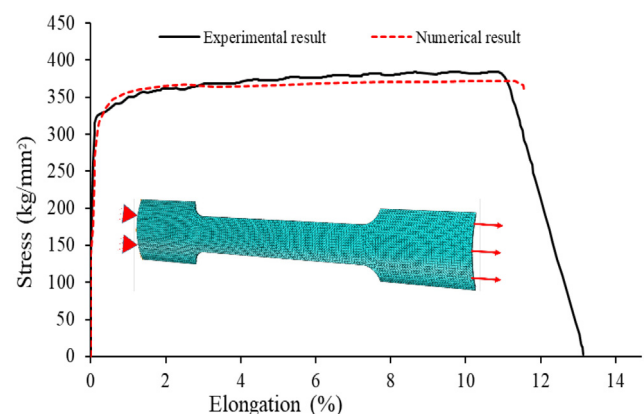
Fig. 3. Stress-strain curve for the steel material.

In the FE analyses, since materials were assumed to have nonlinear properties their behavior was first verified based on the experimental stress-strain curve obtained from the coupon test. Fig. 3 compares the numerical and experimental coupon test results and shows that they

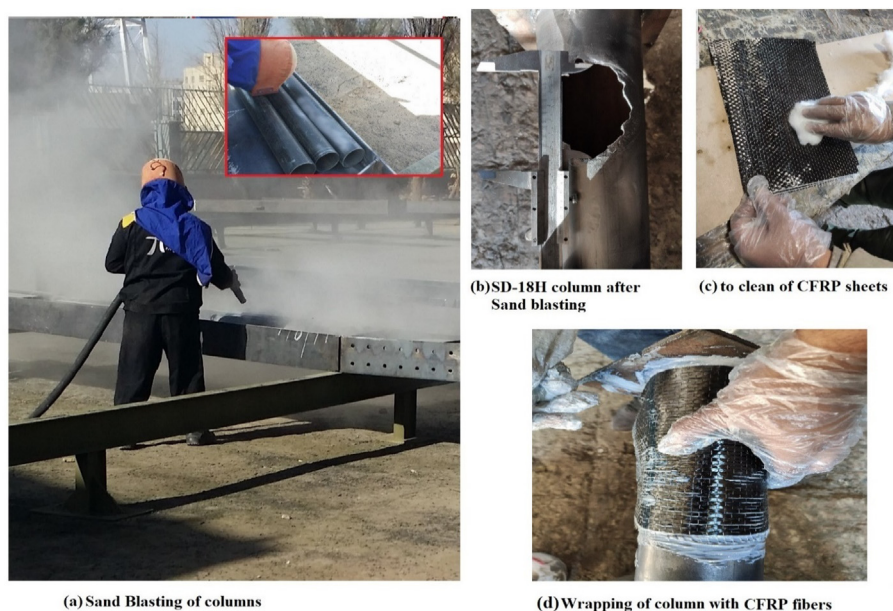
Fig. 9. Preparing CFRP-strengthened specimens.

To achieve a good column-fiber bond, the specimens were sand blasted on the outer surface to eliminate the corrosion, then acetone was used to clean all the contamination from the steel and CFRP surfaces and, finally, CFRP sheets were wrapped around the specimens (Fig. 9) and kept at room temperature for seven days (as the fiber manufacturer had recommended).

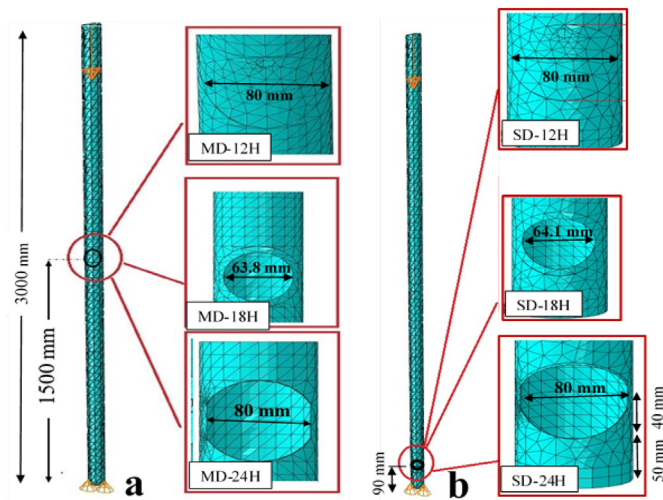
Fig. 13. Numerical views of non-strengthened CHS steel section: (a) mid-height corrosion, (b) near-the-support corrosion.

A total of 10 specimens were studied numerically (Table 3); three were strengthened with CFRP sheets, six were un-bonded and defective and one was un-bonded and undamaged (for controlling purposes). The applied damage depended on the extent of corrosion on the lab specimen; for a 12-hr corroded column, since the thickness was reduced by 1 mm, the same reduction was applied to the model, but in 18- and 24-hr cases, the created cut was equal, in area, to the corroded part of the test specimen. It is noteworthy that eight columns were studied experimentally and numerically and two more were simulated by FE modeling to investigate the effects of the fiber length and 24-hour corrosion in the mid-column. Numerical views of non-strengthened CHS steel section are shown in Fig. 13.

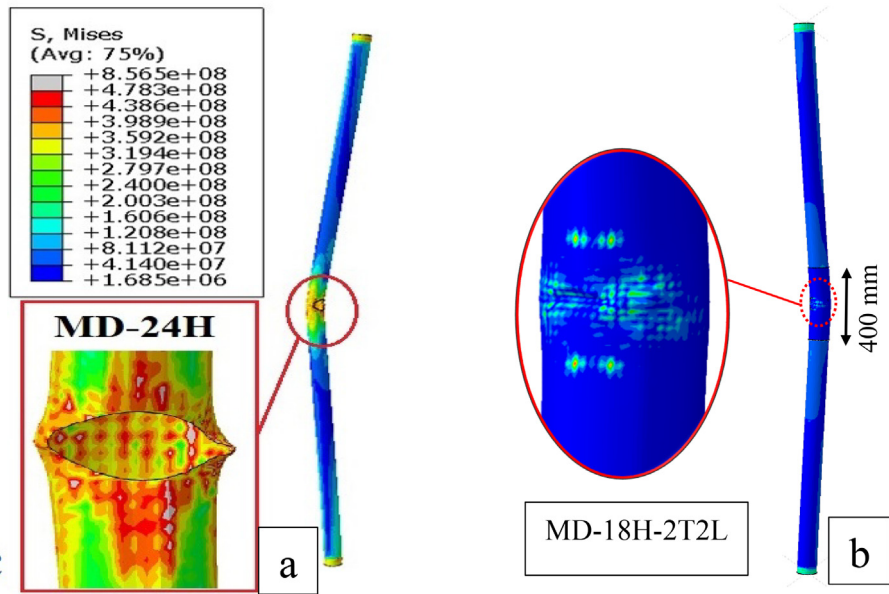
Fig. 21. Failure modes: (a) MD-24H, (b) MD-18H-2T2L with 400 mm CFRP length.

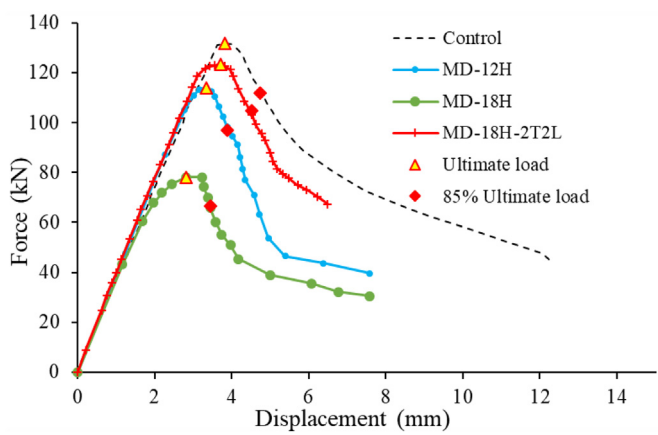
Fig. 22. Experimental load-deflection (vertical) of columns with mid-height damage compared to the control specimen.

Load-Axial shortening curves of the 8 tested specimens are shown in Figs. 22, 23, and 24, and their details plus their maximum load bearing
